Energy Innovators Case Study

WALTER C. MACKENZIE HEALTH SCIENCES CENTRE RESOLVES MAINTENANCE PROBLEM AND REDUCES ENERGY CONSUMPTION

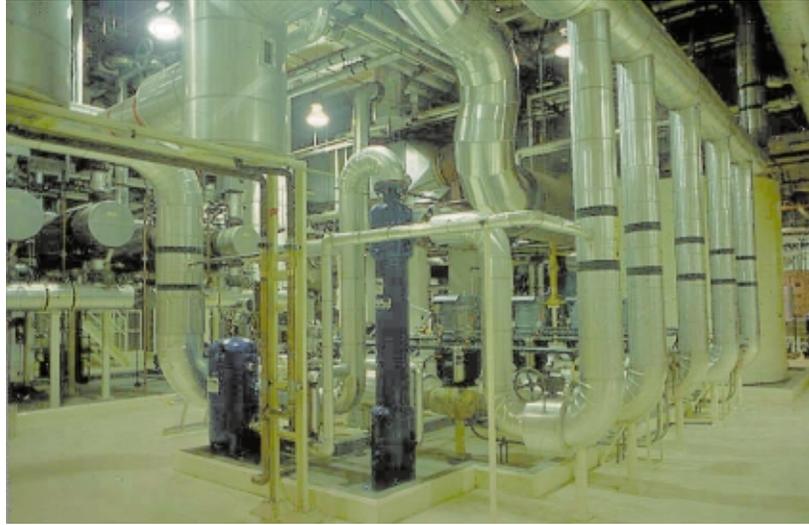
Piping feeds and filter unit at the WCM

Although the root of the problem in the chilled water system was sludge, silt and iron oxide in the cooling water supplied through the District Cooling System, it was initially not easy to identify. The particles were in the 5- to 90-micron range, and, despite its thinness, the layer of contamination that built up on the inside of the cooling coils and other equipment had an impact on their efficiency. Identifying the problem as silt and sludge fouling heat exchangers and plugging chilled water lines was the result of a process of elimination. The UAH resolved the problem through the installation of two 3312-L/min (875-gal./min) centrifugal separators in a side-stream configuration (to keep installation costs down) in the WCM. The utility supplier, the University of Alberta, eventually installed its own similar system in response to the increased efficiencies and energy cost savings that resulted from the WCM installation.

By reducing the contamination of heat exchangers and by improving the chilled water flow rates in all lines, the heat transfer performance and the overall efficiency of all pumps, heat exchangers and other related equipment were dramatically improved. As the variable flow rates through the cooling coils increased (higher load equals higher flow), some of the particulate that was reducing heat transfer capabilities was eliminated, and eventually a portion of the heat transfer capability was regained. This improvement alone made the separators a worthwhile investment for the energy savings, even without considering the reduced maintenance time and expense.
